Contract #: 04-0120F4Cty: SF/ALA Rte: 80 PM: 13.2/13.9File #: 69.28**WELDING INSPECTION REPORT****Resident Engineer:**Pursell, Gary**Address:** 333 Burma Road**City:** Oakland, CA 94607**Report No:** WIR-012267**Date Inspected:** 19-Feb-2010**Project Name:** SAS Superstructure**OSM Arrival Time:** 700**Prime Contractor:** American Bridge/Fluor Enterprises, a JV**OSM Departure Time:** 1900**Contractor:** Zhenhua Port Machinery Company, Ltd (ZPMC), Changxing Island **Location:** Shanghai, China**CWI Name:** Mr.Li Yang**CWI Present:** Yes No**Inspected CWI report:** Yes No N/A**Rod Oven in Use:** Yes No N/A**Electrode to specification:** Yes No N/A**Weld Procedures Followed:** Yes No N/A**Qualified Welders:** Yes No N/A**Verified Joint Fit-up:** Yes No N/A**Approved Drawings:** Yes No N/A**Approved WPS:** Yes No N/A**Delayed / Cancelled:** Yes No N/A**Bridge No:** 34-0006**Component:** Orthotropic Box Girder(OBG)**Summary of Items Observed:**

OBG TRIAL ASSEMBLY

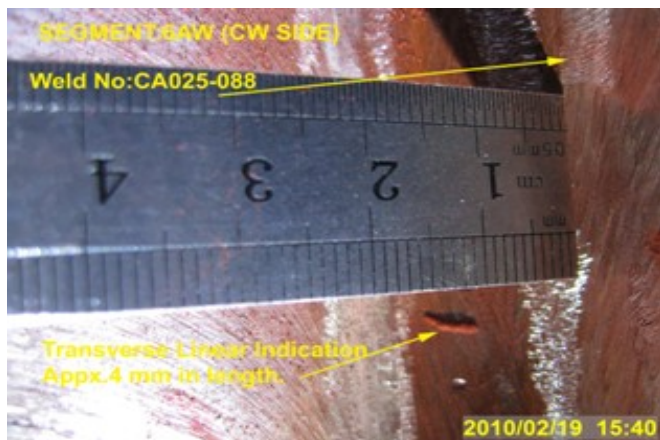
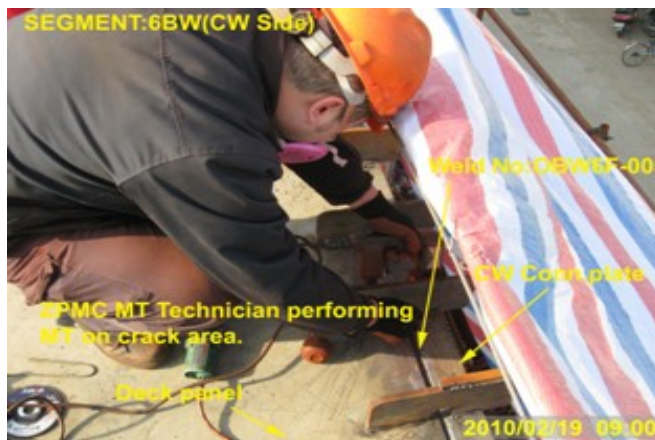
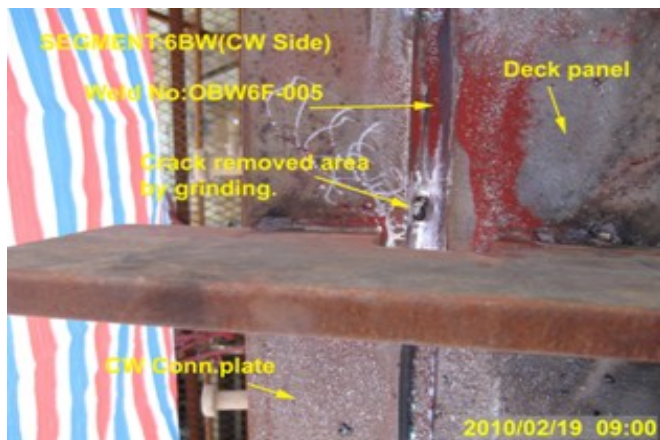
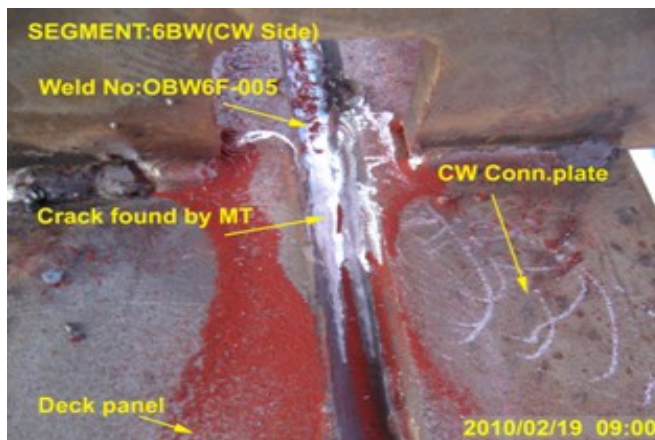
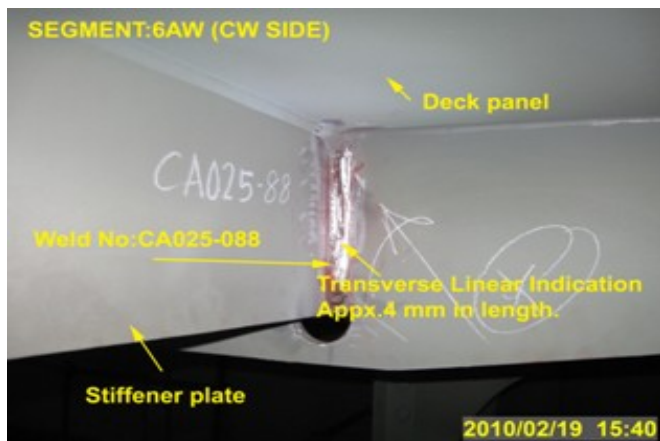
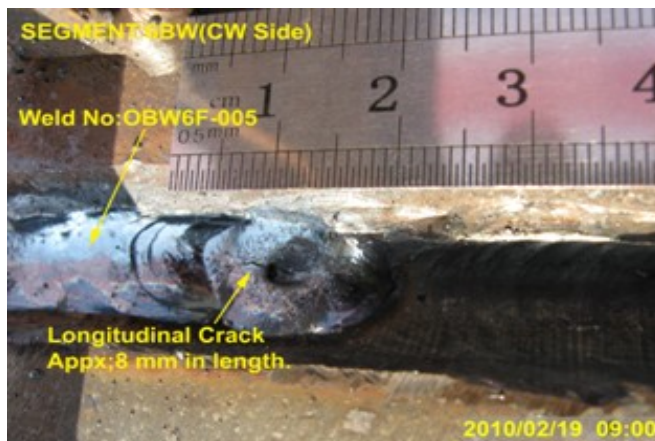
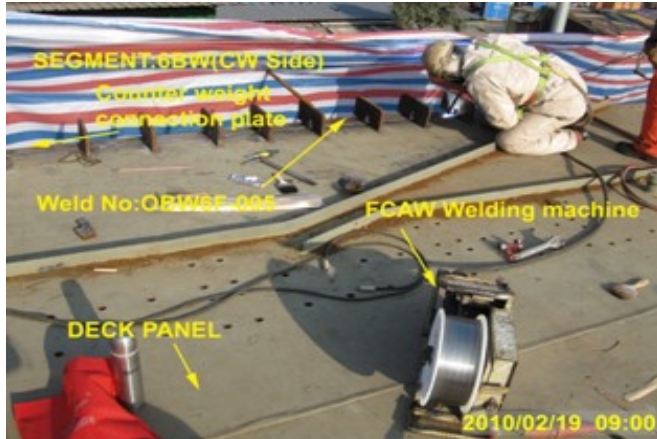
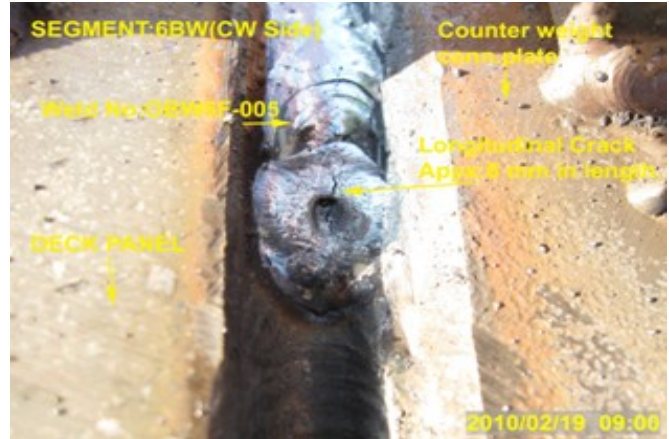
- One (1) Longitudinal Linear crack observed on weld stop point, measuring approximately 8 mm in length.

This QA Informed to ZPMC Certified Welding Inspector (CWI) and CWI offered to perform Magnetic Particle Testing (MT) on crack observed area. ZPMC MT Technician performed MT on this area and he found a crack .

After that this crack has been ground out and performed MT found to be acceptable.
(The attached photographs provide additional detail.)

- One (1) Transverse Linear indication measuring approximately 04 mm in length.
- The weld is identified as: CA025-088.
- The weld is a fillet weld joining X37 plate to stiffener plate.
- Segment 6AW is located near the OBG TRIAL ASSEMBLY AREA.

The Notice of Witness Inspection Number (NWIT) is 005214. The indication is located inside the area that has been previously tested and accepted by ZPMC Quality Control (QC) personnel. As per the contract documents, ZPMC's QC personnel are required to perform 100% MT inspection of these welds.

AWS D1.5 (02) Section 6.26.2 – “Welds that are subject to MT in addition to visual inspection shall have no cracks”.
